June 10, 1999 MDEQ Field Inspection Report

# MONTANA DEPARTMENT OF ENVIRONMENTAL QUALITY

### OPERATING PERMIT - FIELD INSPECTION REPORT

Operating Permit No.: 00010 Project: Libby vermiculite mine County: Lincoln

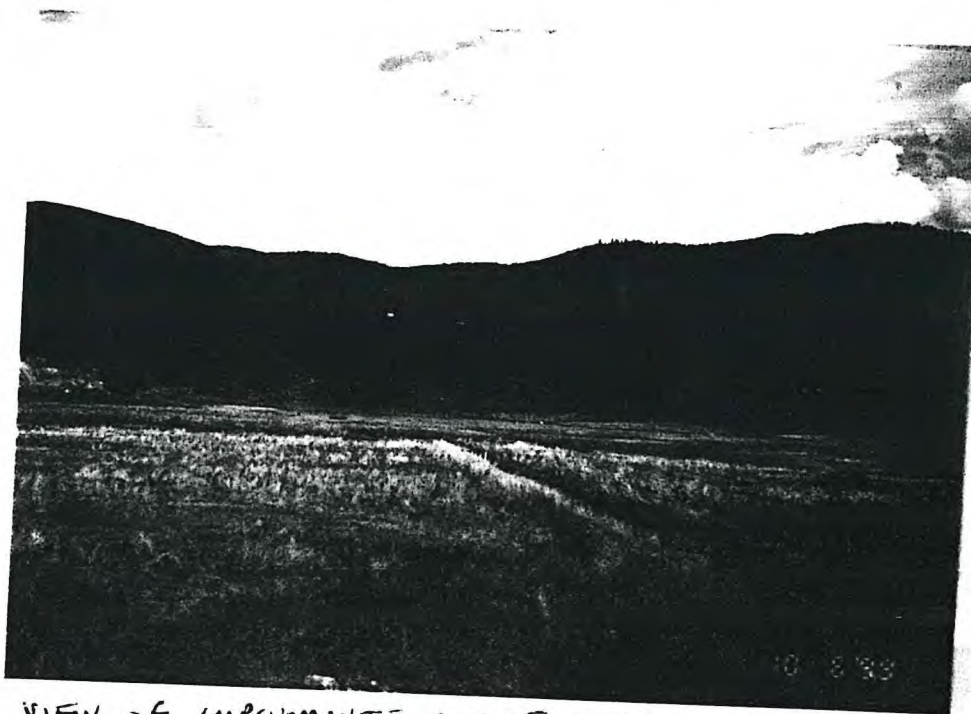
PHOTO  
#1  
1

Next we toured the impoundment site which is also out of the permit boundary. The Dam Safety Program (DSP) in DNRC has just inspected the facility and gave it their approval. The impoundment wetland vegetation continues to expand each year (see Photo 1). The DSP told KDC to cut down the largest of the trees on the embankment slope. The impoundment receives extensive use from waterfowl, frogs, moose, etc. KDC just completed water quality analysis of the toe drains from the impoundment. Water quality continues to improve and all standards are being met.

VIEW OF IMPOUNDMENT OUTLET STREAM CHANNEL.  
WETLANDS CONTINUE TO EXPAND ON IMPOUNDMENT SURFACE.  
DAM SAFETY BUREAU HAS JUST GIVEN BLESSING ON KOC'S  
IMPOUNDMENT PLANS & MAINTENANCE.

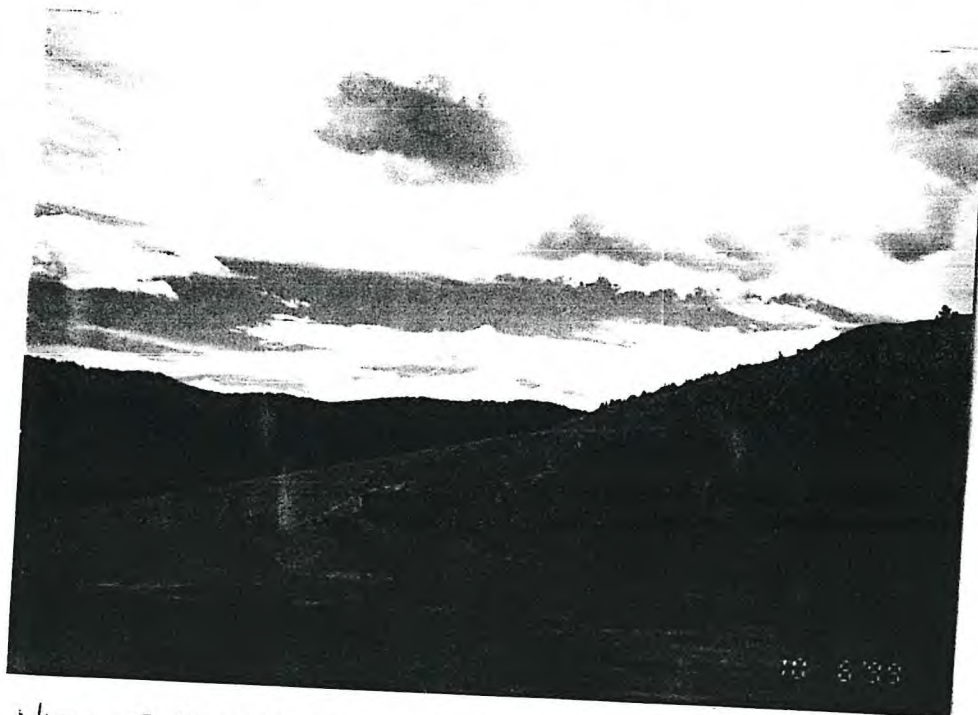
PHOTO #2

The impoundment receives any sediment that washes off the coarse tailings area that is currently in the permit boundary (see Photo 2). No sediment reports to Rainy Creek out of the impoundment area. The coarse tailings area continues to stabilize more and more every year. Fertilization of the tailings would help improve the growth of the vegetation but KDC and DEQ have been reluctant to recommend and implement this practice because of the well drained nature of the coarse tailings and the potential for nitrates to reach Rainy Creek. This has slowed the development of the vegetation on the slopes. Erosion will continue until a stable equilibrium is reached. KDC continues to maintain diversions across the slope to limit erosion and continues to regrade and patch rills and gullies as needed each year. There are no offsite impacts from the annual erosion from the coarse tailings area. The impoundment has plenty of excess capacity to hold any eroding materials from the coarse tailings area over time.

VIEW OF CHARGE THINGS AREA. AREA CONTINUES TO  
STABILIZE MORE & MORE EVERY YEAR. SEDIMENT  
RESETS TO IMPOUNDMENT & DOES NOT GET TO RAINY CREEK.  
EROSION WILL CONTINUE UNTIL A STABLE EQUILIBRIUM  
IS REACHED. KOC CONTINUES TO MAINTAIN DIVERSIONS  
ACROSS THE SLOPE.

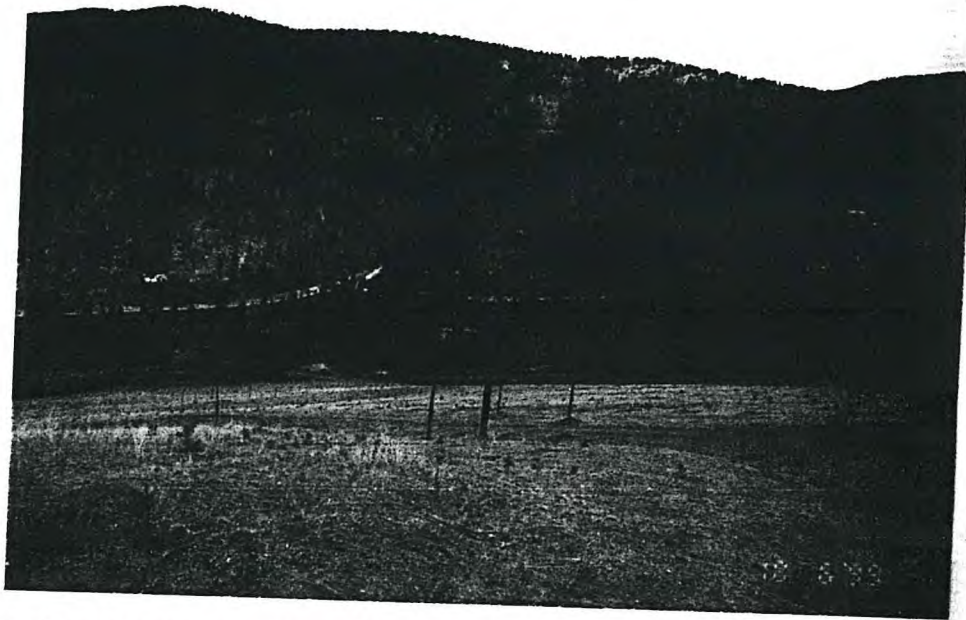
PHOTO  
# 3

Planted trees continue to grow in the coarse tailings area (see Photo 3). Progress will continue slowly as soil develops and organic matter accumulates. The erosion is limited. The sediment is contained in the impoundment. The water quality is above standards from the impoundment area. The DSP has approved KDC's maintenance and operations plan for the impoundment. Erosion will continue for an unknown number of years, but there is no offsite impacts. The coarse tailings area is ready for bond release.

COARSE TILLAGE AREA FROM ABOVE. PLANTED TREES CONTINUE TO GROW. GROWTH IS SLOW CAUSE OF INHERENT INFERTILITY OF MATERIALS. FERTILIZER USE WOULD HELP BUT COULD COMPLICATE WATER QUALITY PROBLEMS CAUSE OF EXCESSIVE DRAINAGE. PROGRESS WILL CONTINUE SLOWLY AS SOIL DEPLETS + ORGANIC MATTER ACCUMULATES.

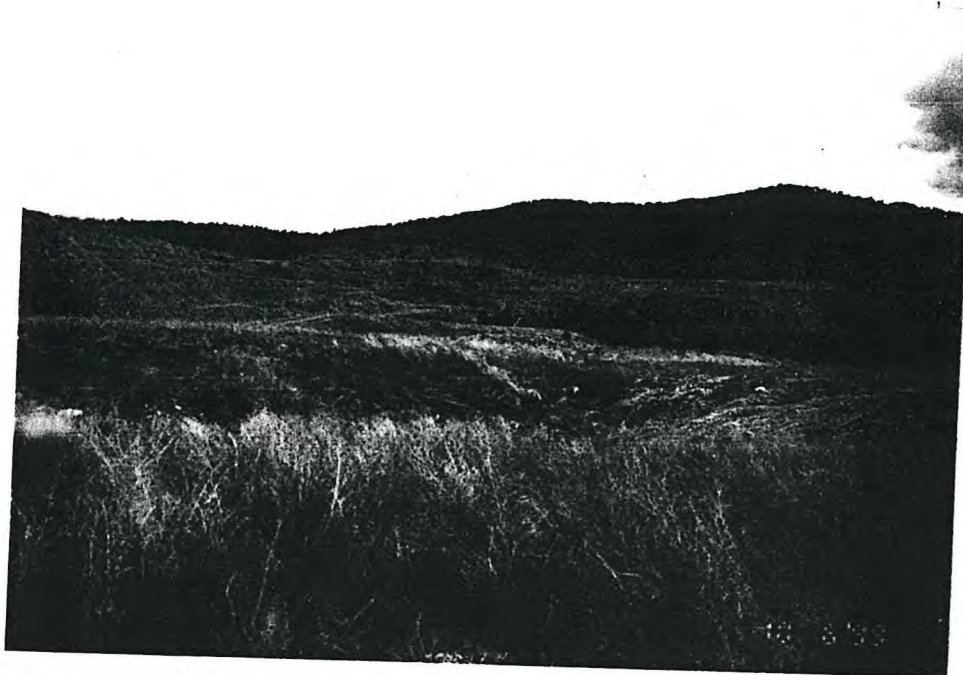
PHOTO # 4

Next we inspected the Glory Hole area and syenite rip rap borrow areas. These areas have been reclaimed and the vegetation is well established. They are ready for full bond release (see Photo 4).

GLACIAL HOLE AREA: AREA HAS BEEN RECLAIMED, + SLOPED. SOME BARE AREAS RECLAIMED AS WELL.

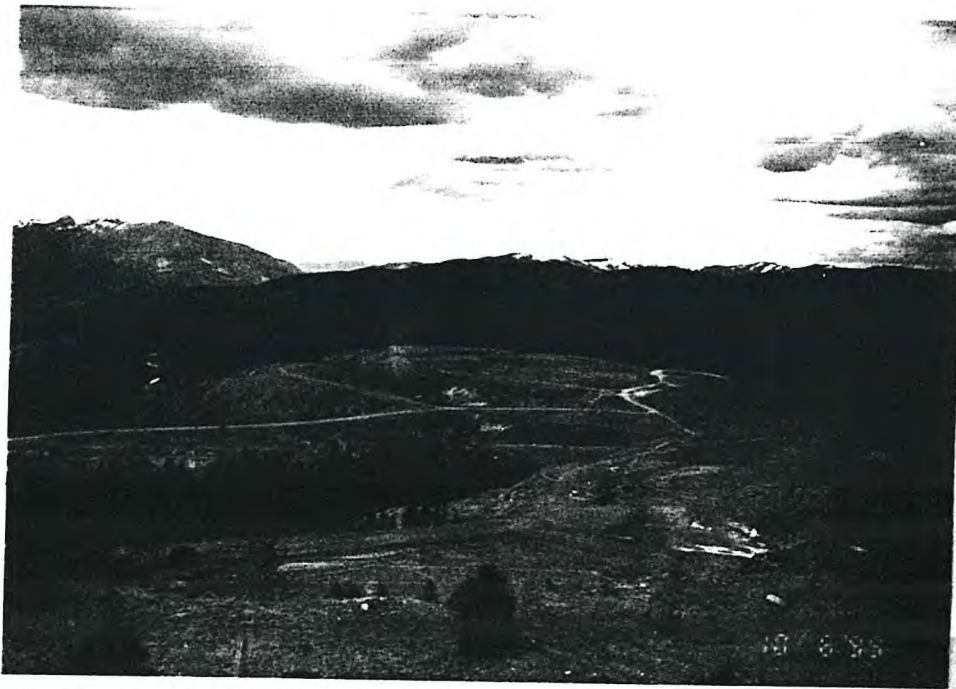
PHOTO #5

VIEW FROM KNSB SURVEY POINT OF RECLAIMED MINE & WASTE ROCK DUMP RELEASED FROM PERMIT AREA. RECLAMATION CONTINUES TO IMPROVE SLOWLY. TREES IN FOREGROUND CONTINUE TO GROW.

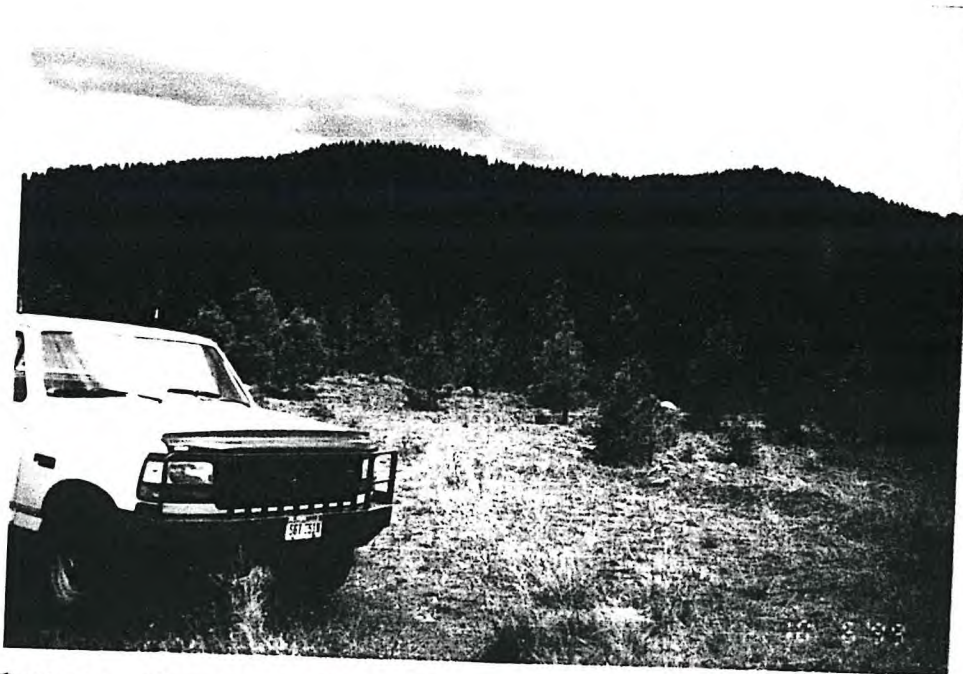
PHOTO #6

SURVEY KNSB: TREES HAVE GROWN SUBSTANTIALLY SINCE BOND RELEASE.

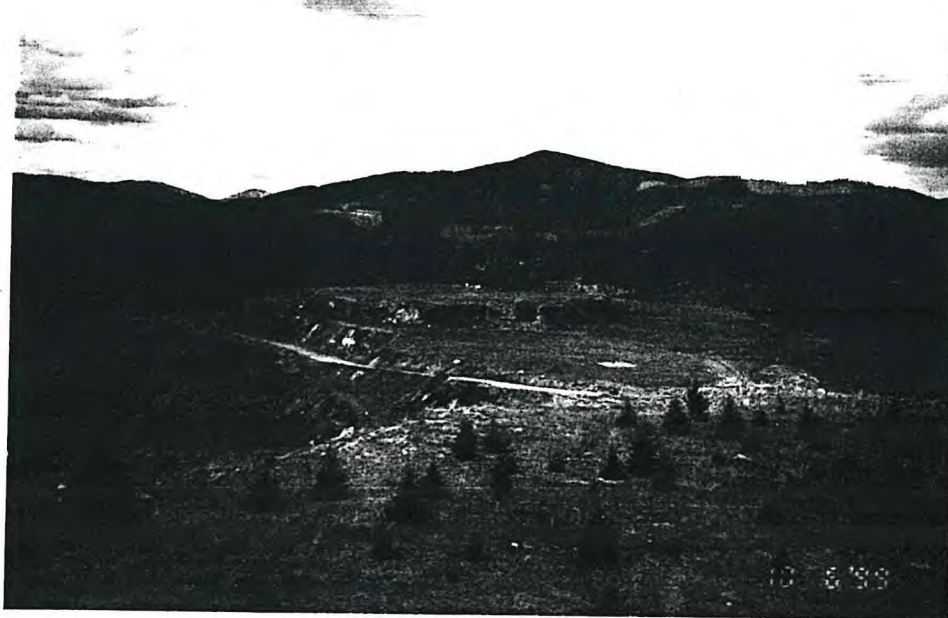
PHOTO  
#7

VIEW OF OTHER KNOPS FROM SURVEY KNOP, MINE HIGHWAYS  
CONTINUE TO RAVEL + STABILIZE AT ANGLE OF REPOSE. TREES  
IN FOREGROUND HAVE GROWN SUBSTANTIALLY SINCE BOW REVERSE.
